SERVICE BULLETINS

Model Code	Side Label	Part No.				
		Panel Module	Inverter	T-Con	Main B'd	Power
LN40D630M3FXZA	SQ01	BN07-01032A	BN81-06514A	BN81-06512A	BN96-19438A	BN44-00464A
	SN02	BN07-01037A	BN81-06720A	BN81-06719A	BN96-19774A	BN44-00464A

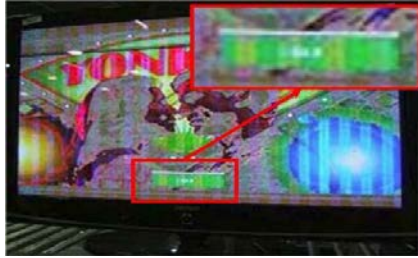
If Picture & Display errors
Defective Main Board, LVDS,
or T-CON

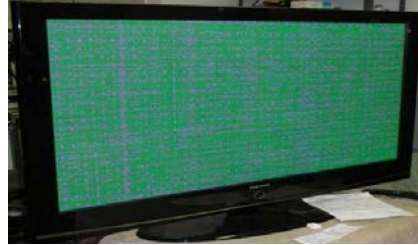
Green lines or a green screen
defective main board , LVDS , or
T-CON.

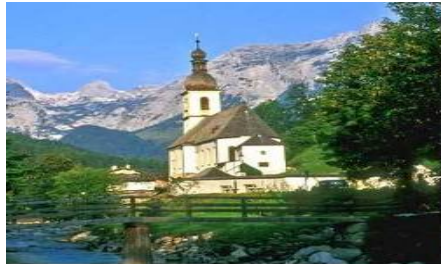
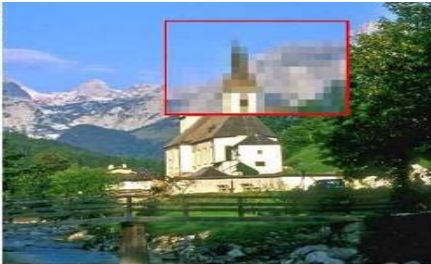
Pixelization can be caused by the main board
but is more commonly a source error

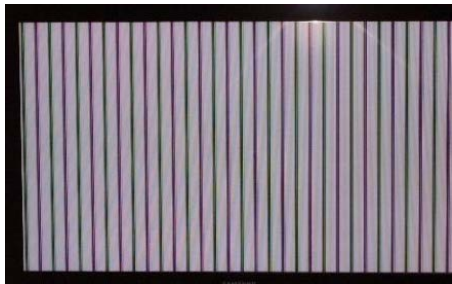
Vertical or Horizontal Lines :Defective
Panel likely but also T-CON, LVDS, or Main
Board. Use Test Patterns in Factory Service
Mode to determine error)
